G-III-B-127

Otto Goehringer Farm
Private
Accident vic.

The Otto Goehringer Farm consists of a house and barn. The house is a two-story, gable-roofed, ell-plan dwelling with a symmetrical, two-bay facade.

INVENTORY FORM FOR STATE HISTORIC SITES SURVEY

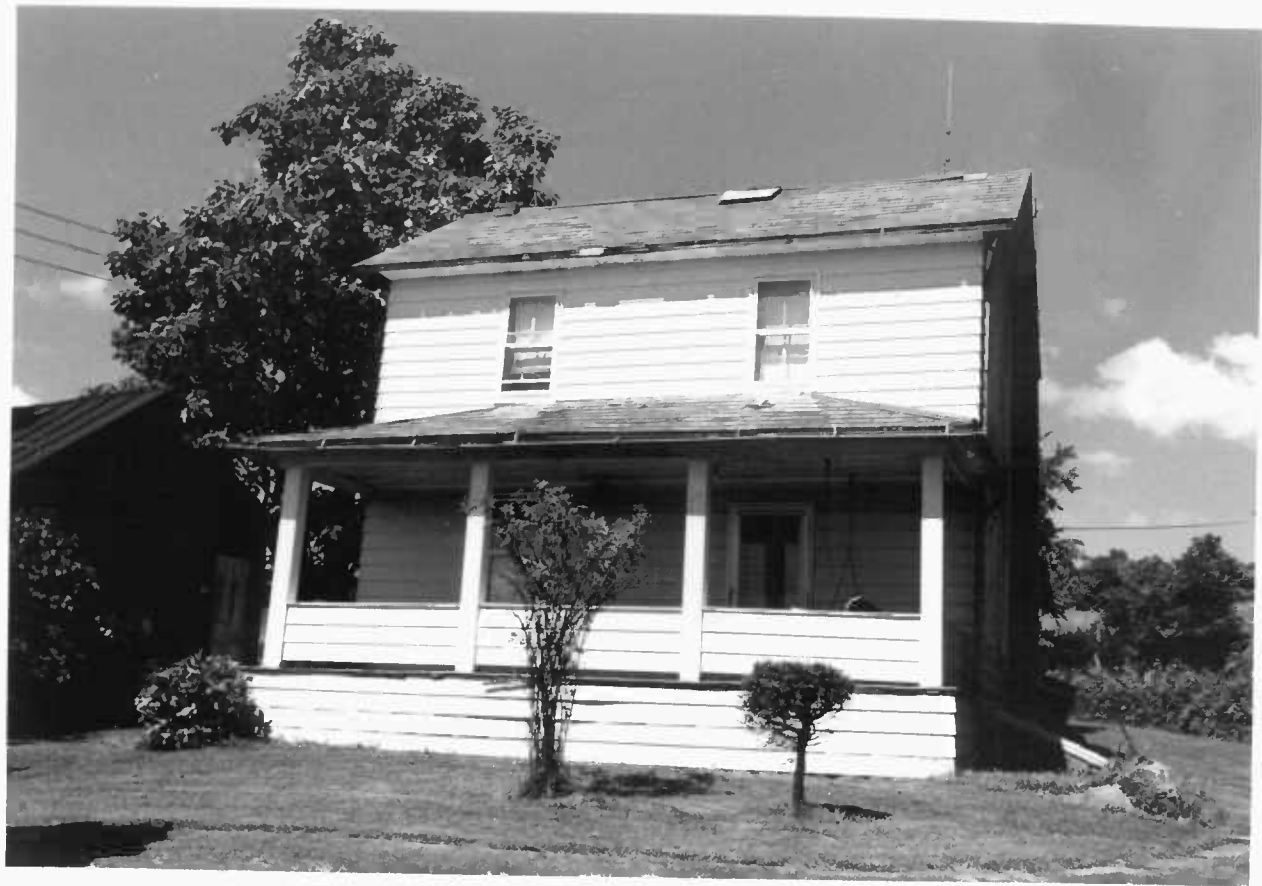
G-III-B-127

The house is a two-story, gable-roofed, ell-plan dwelling with a symmetrical, two-bay facade. The facade points southeast and its first floor is covered with a hipped-roofed porch. On the northeast elevation, the ell is filled with a one-story, enclosed, shed-roofed porch.

The house rests on a low stone foundation and is covered with aluminum siding over German siding. The windows are 2/2 sash with mitred surrounds. The facade door, in the east bay of the facade, has two glass panels in its upper half.

The roof is slate. The house has two stove chimneys: an interior brick chimney at the southwest gable end of the main block, and an exterior cinderblock chimney on the northeast gable end of the main block. The facade porch has an asphalt roof supported by square posts.

Facade: SE elev.

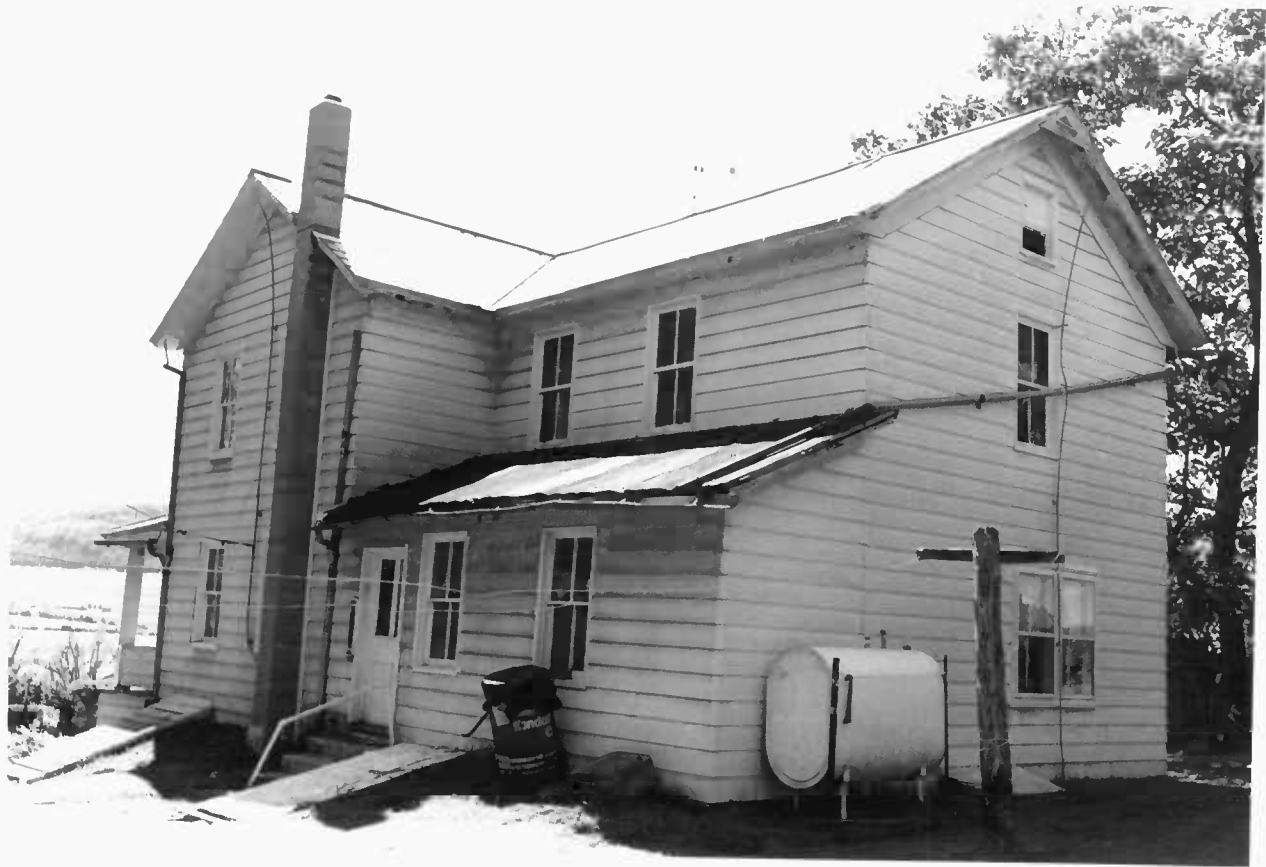
G-III-B-127

NE & NW elevs.
